Re: **Further Site Investigation**
Michigan Plaza
3801-3823 West Michigan Street
Indianapolis, Indiana 421325
IDEM Incident # 0000198
MUNDELL Project No. M01046

Re: **Indoor Air Mitigation System Installation Report – September 2006**
Michigan Plaza
3801-3823 West Michigan Street
Indianapolis, IN
MUNDELL Project No.: M01046

**AIR MITIGATION SYSTEM LOCATIONS
MICHIGAN PLAZA**

**INDOOR AIR SAMPLING RESULTS
MICHIGAN PLAZA**
3801-3823 West Michigan Street
Indianapolis, Indiana

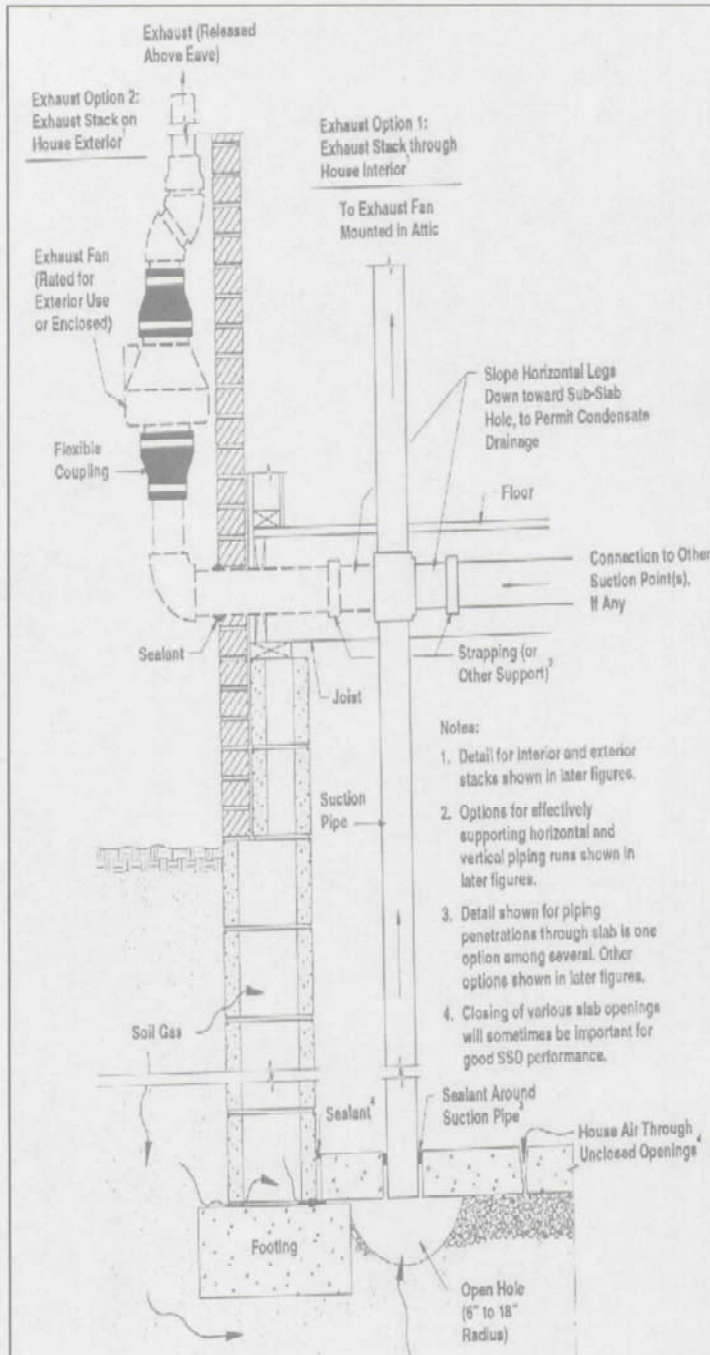
Figure 1. Sub-slab depressurization (SSD) using pipes inserted down through the slab from indoors

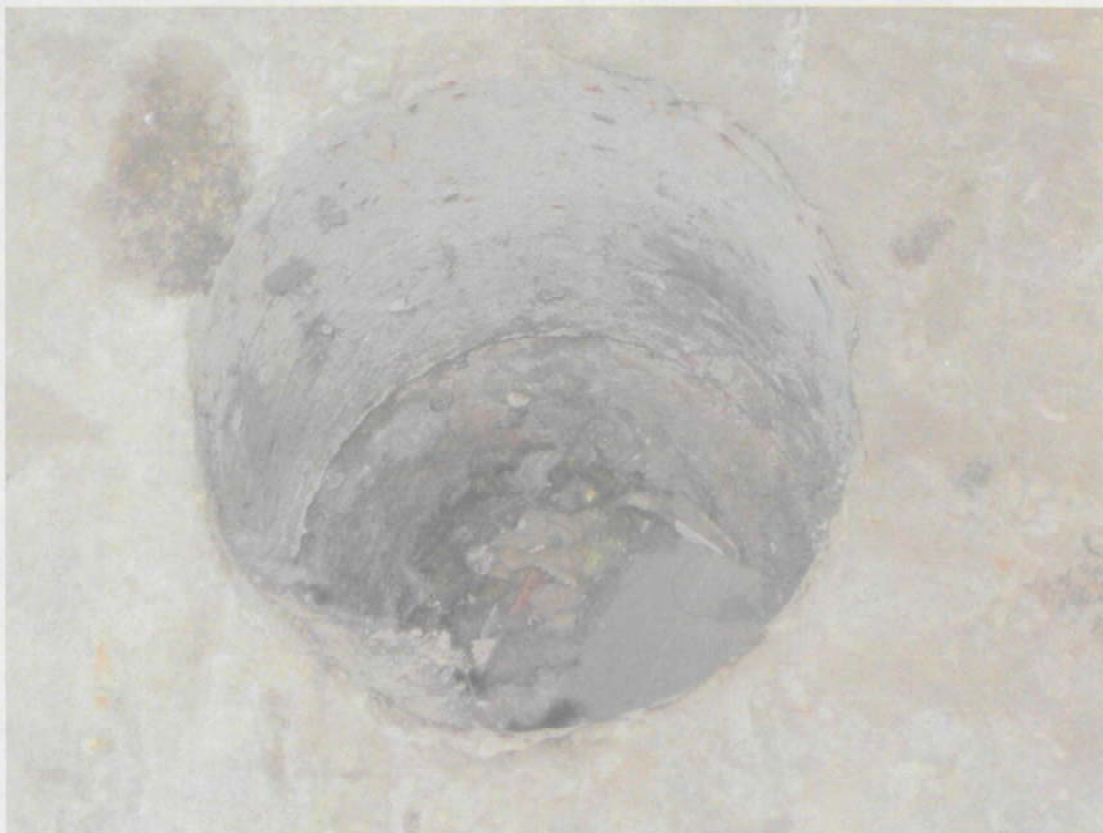
Photo 1: Coring into the slab (3819)

Four sub slab depressurization units were installed by *Air Quality Control (AQC)* under the oversight of MUNDELL from September 14th 2006 through September 21st 2006. There was a unit/blower installed in the following spaces at Michigan Plaza: i) Village Pantry (B-1), ii) Former Handicap Space (B-2), iii) Mexican Store (B-3), and iv) Laundromat (B-4). The system locations are illustrated in **Figure 1**. The system installation involved coring through the slab in each of the four spaces with a 'Bosch' hammer drill (**Appendix A: Photo 2**). A 'vapor collection chamber' (**Appendix A: Photo 1**) was created beneath the concrete floors at pre-selected locations. It was confirmed that there was porous material (pea-gravel) in the vicinity of the collection chamber in order to achieve maximum suction of the sub-slab vapors (**Appendix A: Photo 3**).

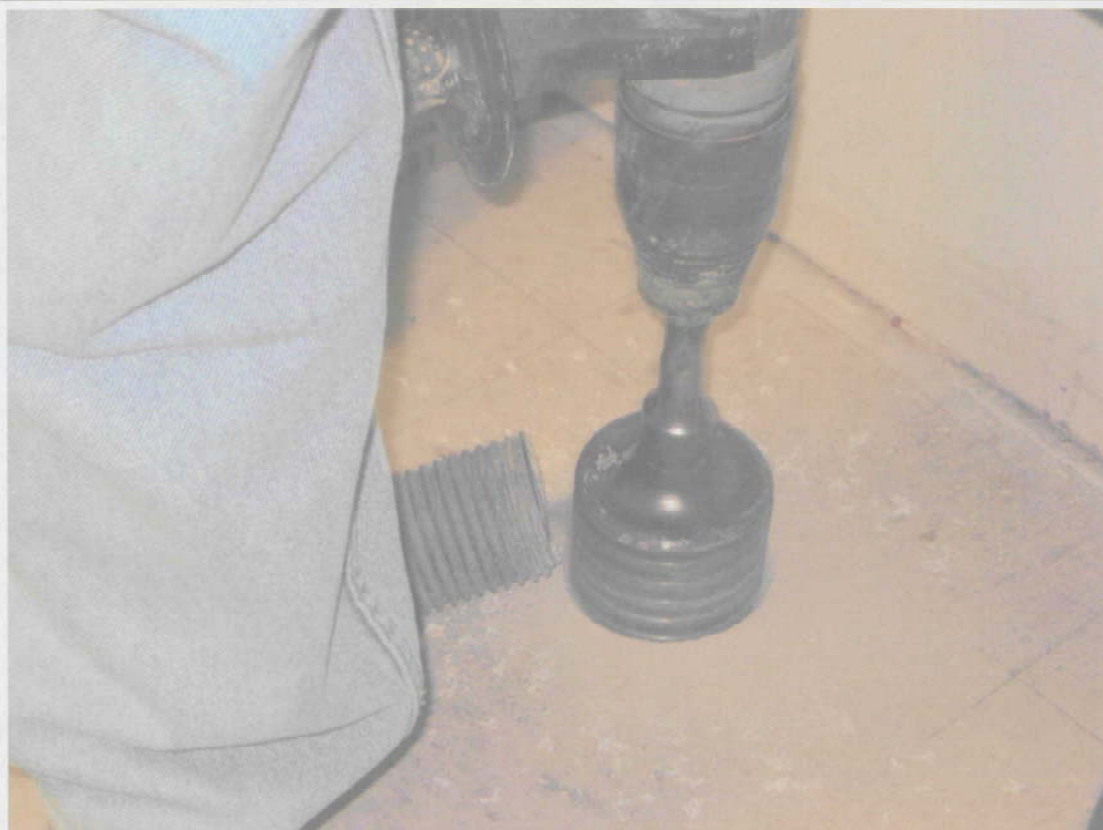
Photo 2: The coring process (3819)

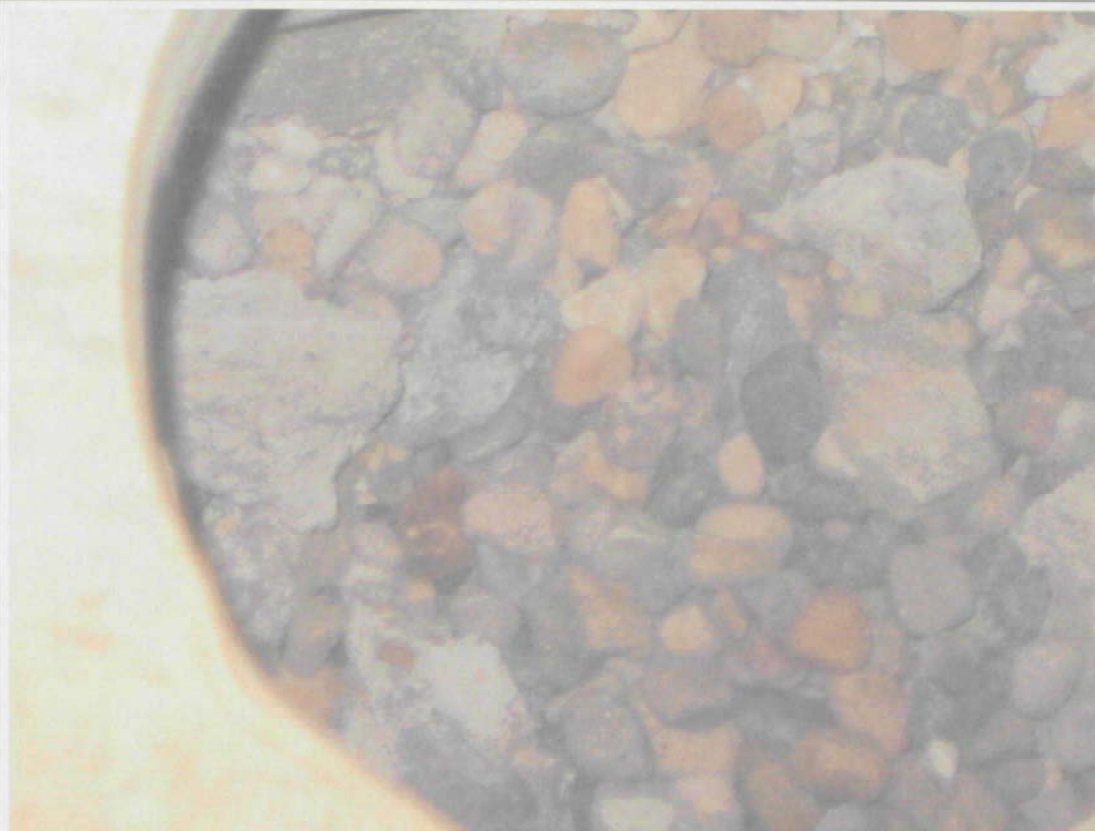
Photo 3: The sub-slab pea-gravel (3819)

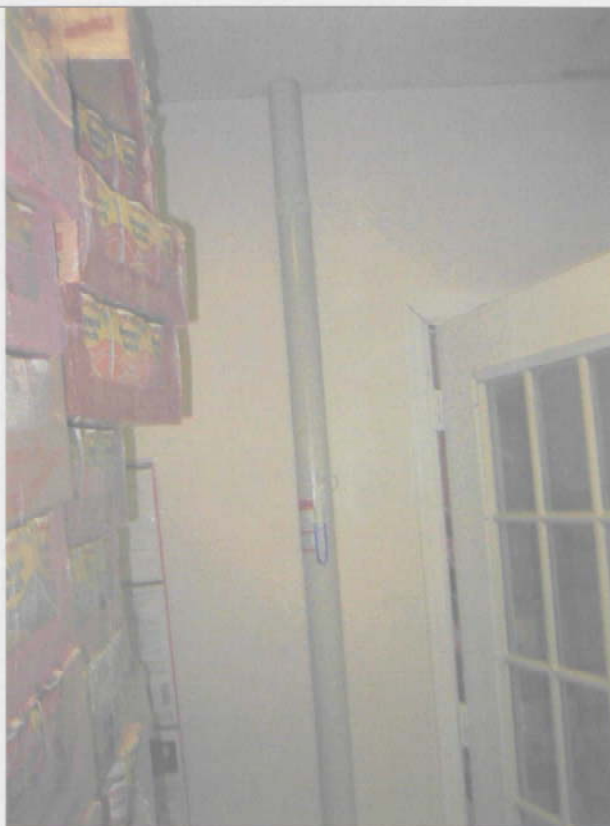
Photo 4: The plastic suction pipe with the U-tube manometer (3819)

Differential pressure gauges were installed on pipes to monitor/display fan vacuum pressures. (*Appendix A: Photos 4 & 11*). The power circuits were installed to supply power for the blowers. Sampling ports were also installed onto the suction pipes to enable drawing of system samples in the future. All the four units were tuned up and running by September 21st 2006.

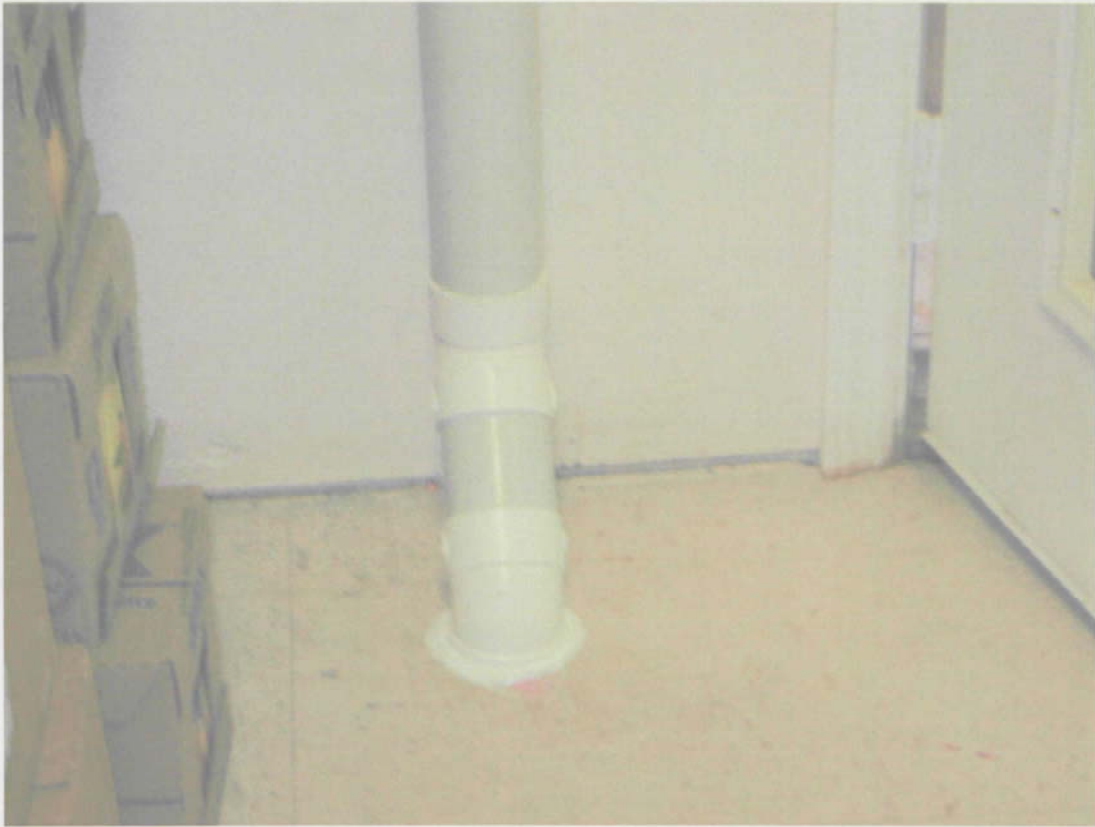
Photo 5: Suction point in the 3819 space

Plastic vent pipes were installed into the collection chambers and the suction points were sealed in place in the concrete floor (**Appendix A: Photo 5**). Primary suction pipes ran from the collection chambers to the nearest outside wall. The centrifugal inline blowers (RP-145 series) were installed

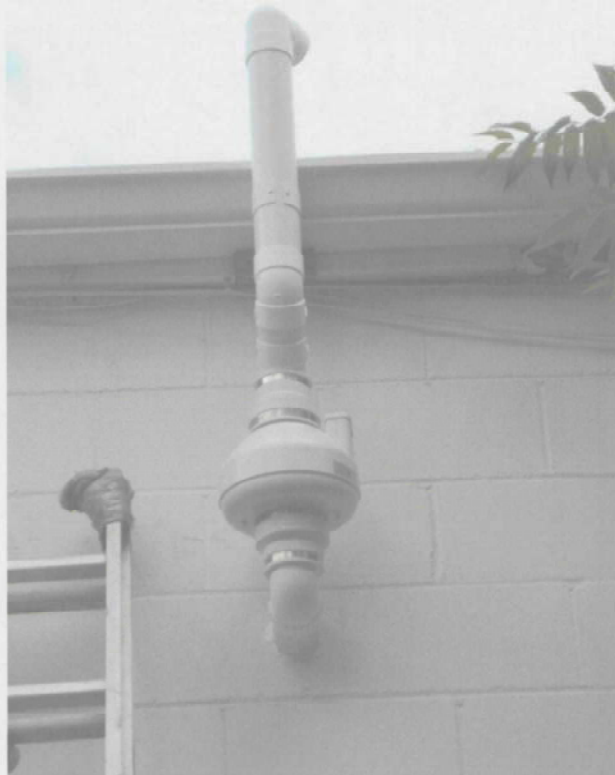
Photo 6: The blower (RP 145) on the 3819 outside wall

on the exterior and the exhaust pipe was continued to the roofline (safe discharge locations) (*Appendix A: Photos 6 & 10*).

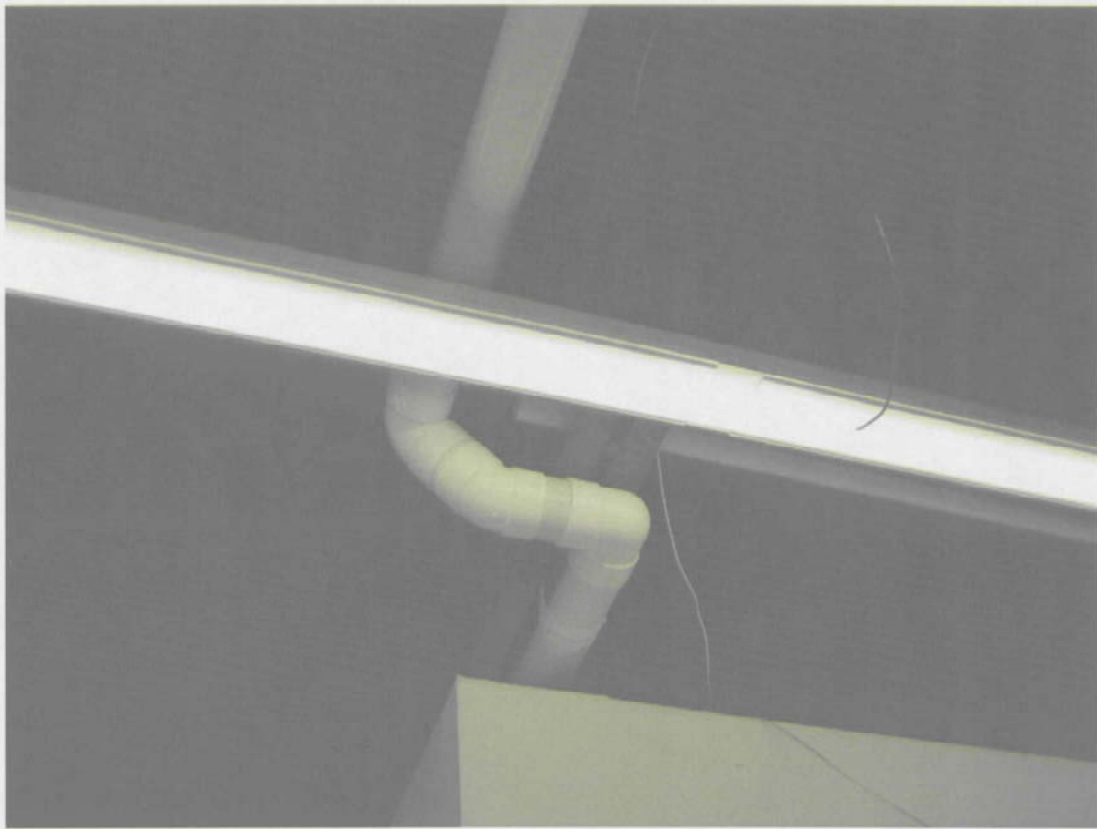
Photo 7: Piping inside the building

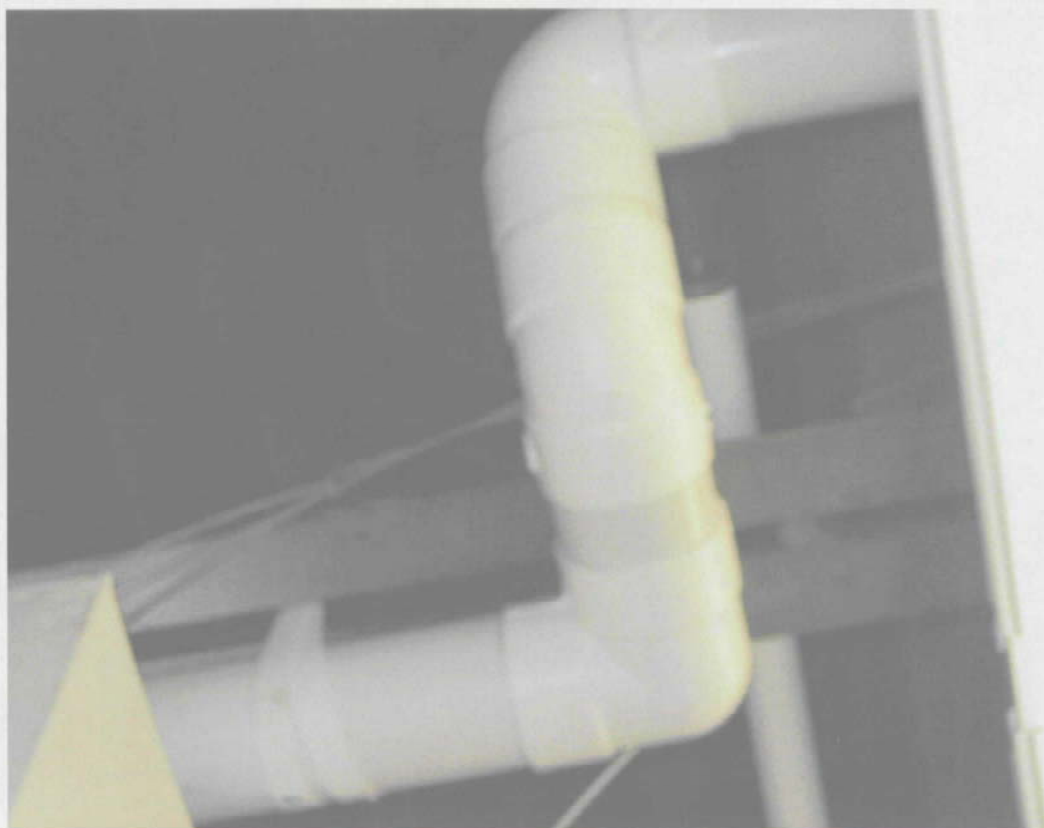
Photo 8: More piping

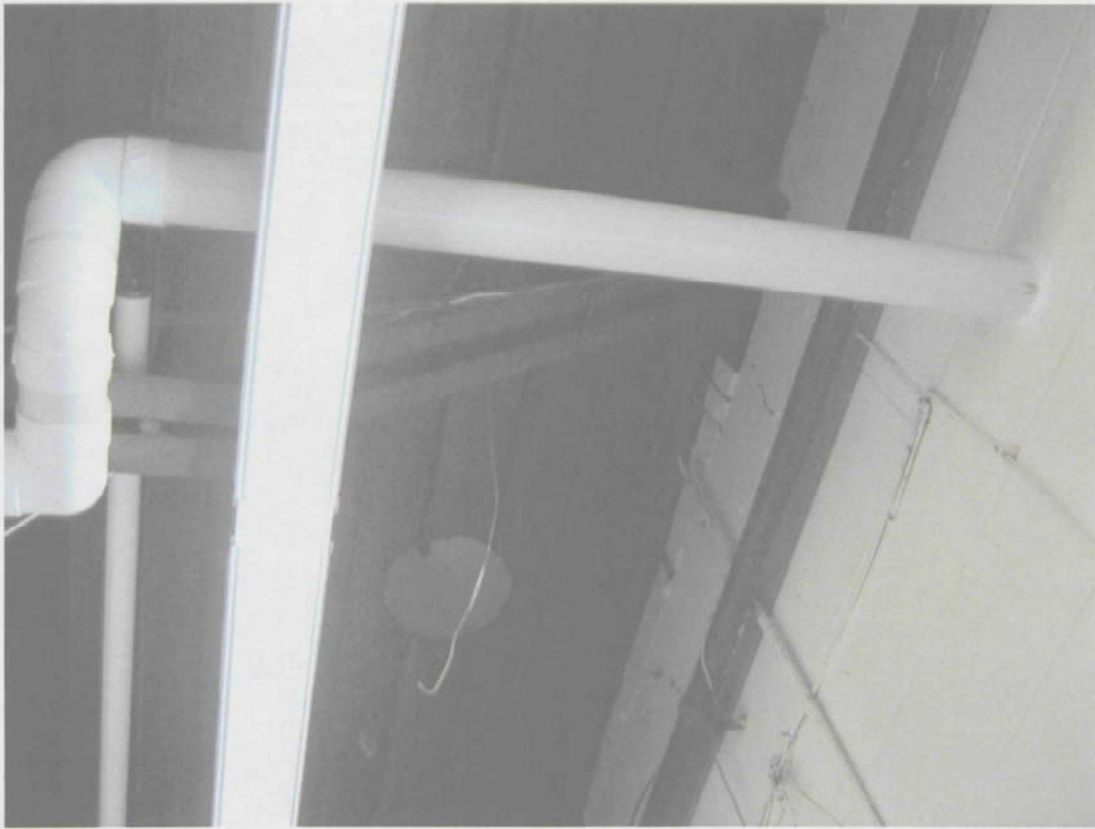
Photo 9: Piping proceeding outside through the wall

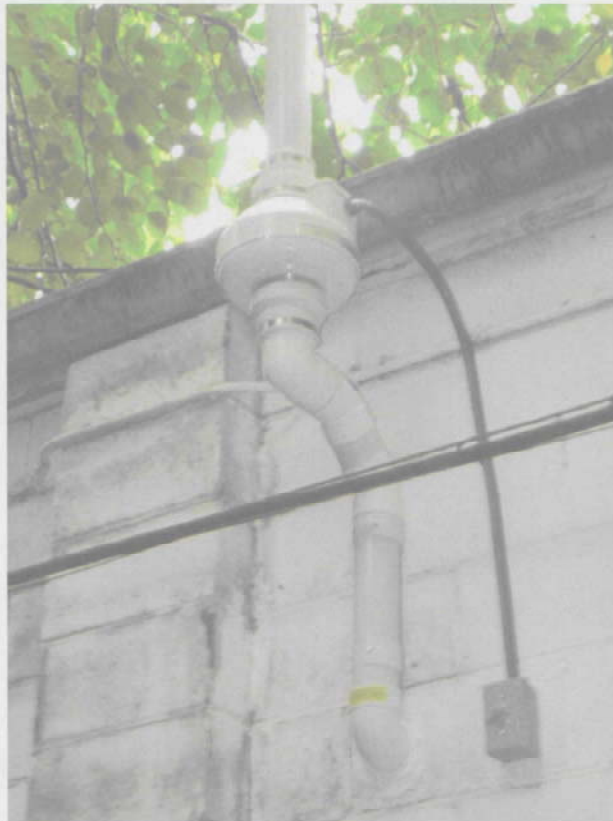
Photo 10: The unit with the suction point inside the handicap work shop

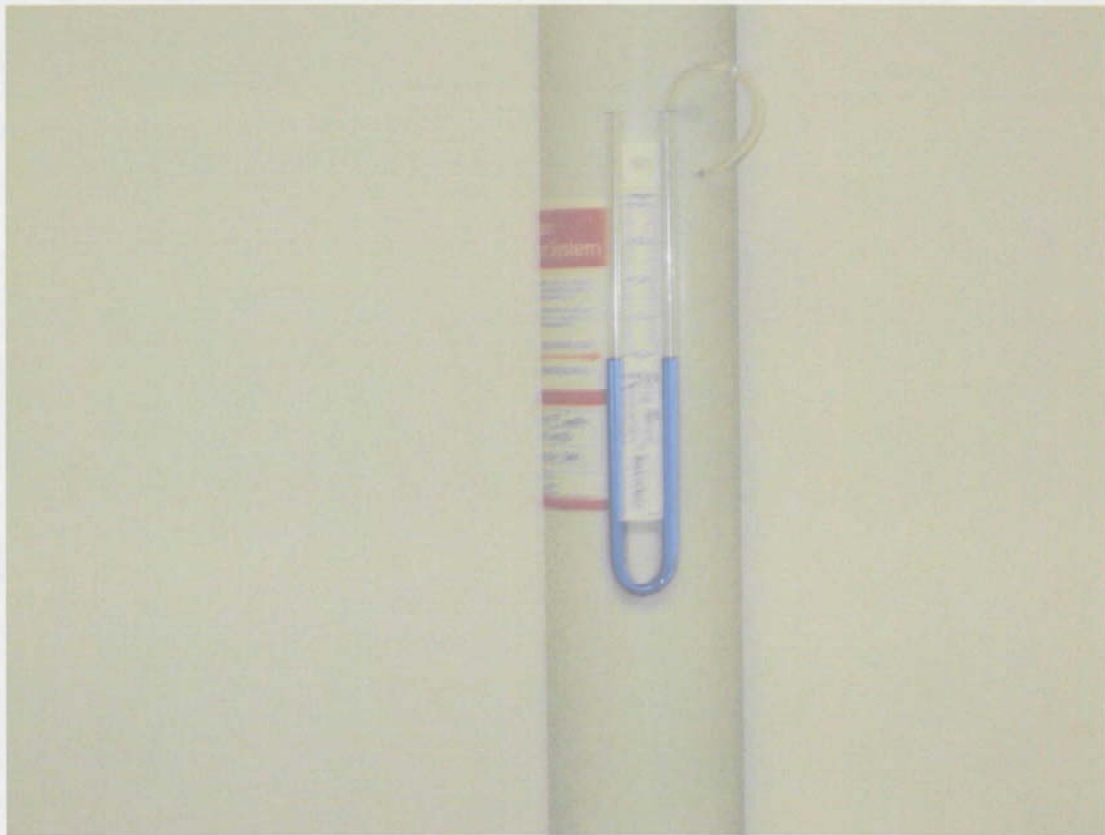
Photo 11: The manometer (static pressure reading / space 3815)

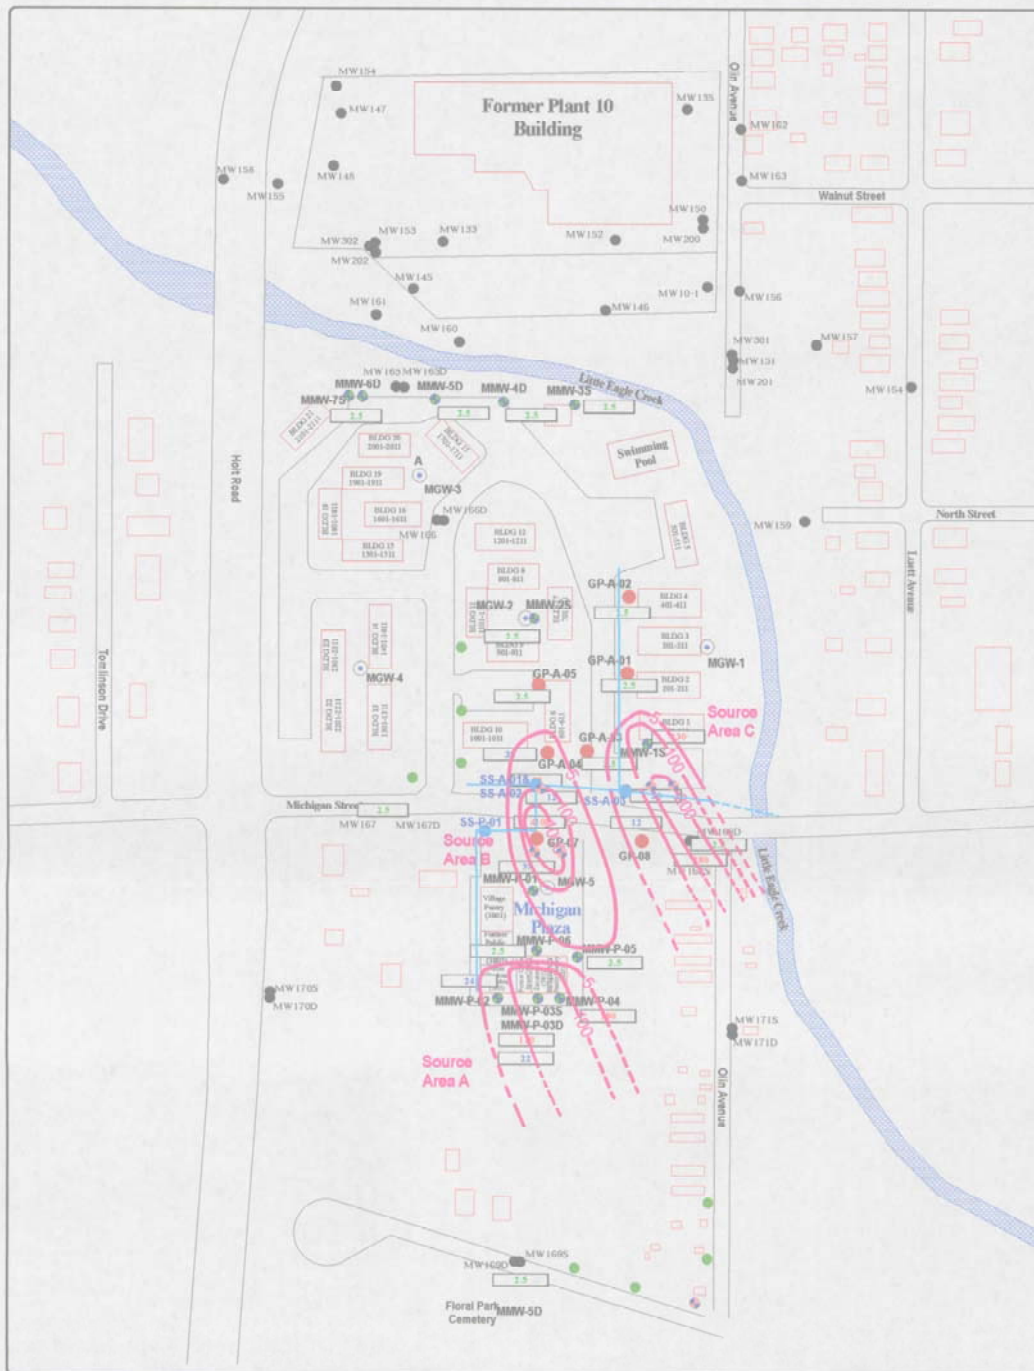
C1

- Fence
- MW 160 ● Keramida Monitoring Wells
- SS-P-01 ● MUNDELL Sewer Sampling Locations (September & November 2005)
- GP-07 ● MUNDELL Soil Boring Locations (September 2005)
- MMW-P-06 ● MUNDELL Monitoring Wells, Michigan Plaza (September 2005)
- Total PCE concentration in groundwater, ppb
- 10 — Total PCE concentration in groundwater, ppb
- Sewer Line Location
- MUNDELL Proposed Soil Boring Locations (October 2006)
- MMW-P-06 ● MUNDELL Proposed Monitoring Wells (October 2006)

- 1) Three (3) additional monitoring wells downgradient of *Source Area B* (as shown in **Appendix C**).
- 2) Two (2) additional monitoring wells downgradient of *Source Area C* (as shown in **Appendix C**).
- 3) Five (5) geoprobes (with groundwater samples) and one (1) monitoring well downgradient of the Plaza along Cossell Road and Olin Avenue (**Appendix C**).
